# Power Steering Control Valve Rebuild

## *The Hitch Guide to Rebuilding a PSCV*

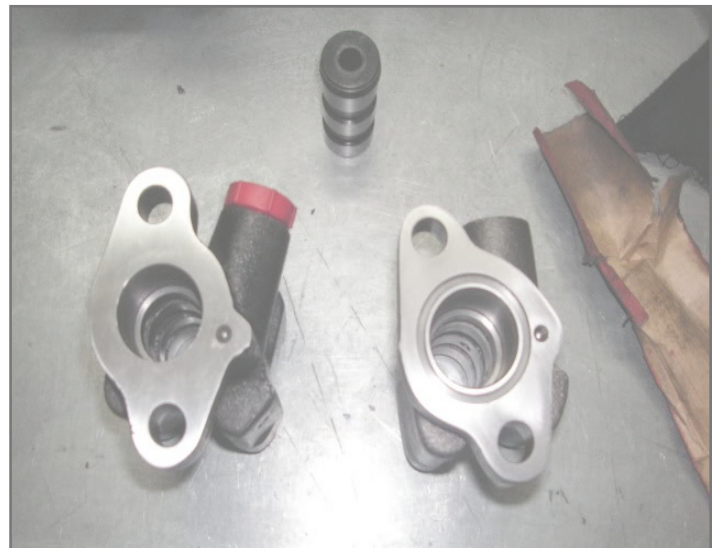
**Figure 1: Valve housing smooth vs. o-ring groove**

<sup>1</sup> See NCRS Tech Board link in References for full discussion of the o-ring groove vs smooth surface to the PSCV housing

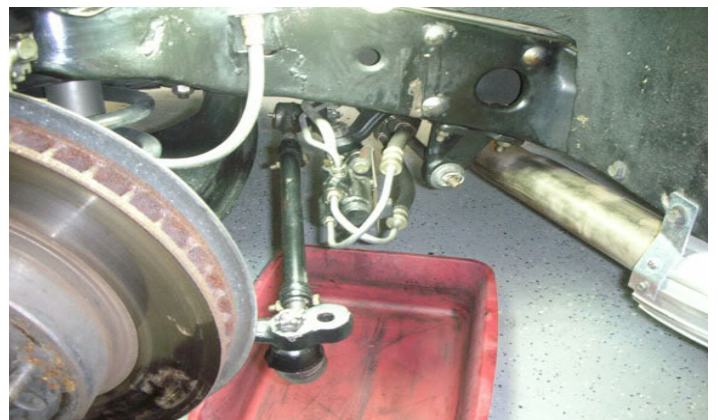
**Figure 2: The Power Steering Control Valve**

The hardest part was separating the ball stud from the pitman arm. I have read that using a pickle fork is not a good idea on the PSCV. However I have tried my tie rod puller and there is not enough room so I had to use the pickle fork. If anyone has a picture of said ball stud separator that will fit in the confines of a midyear frame it would be greatly appreciated. The only way that you can effectively get to the ball stud to separate it with the pickle fork is to do as follows. Remove the four nuts that secure the power steering ram and let it hang down. You will need to have the car up on jackstands to get under the car. Turn the wheels to the right so that the pitman arm is pretty much at the center of the car. Then place the pickle fork perpendicular to the control valve and hammer away. It is necessary to be perpendicular as this is the only way that the pickle fork is not binding on the housing bolts (Figure 2).

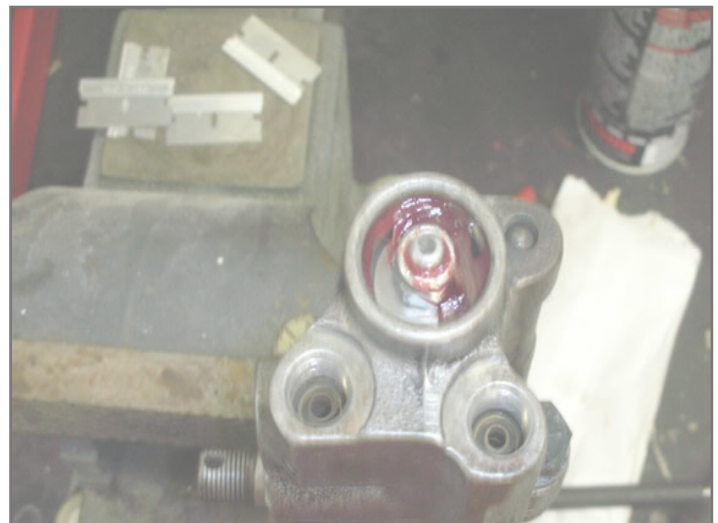
**Figure 3: PSCV adjusting nut (dust cap removed)**

With the PSCV off and on your work bench, secure it in the vise and remove the dust cover (Figure 3). There

is an adjustment nut under the dust cap that controls the PSCV (Figure 3). As you remove the adjustment nut, it is important that you count the revolutions or number of turns. Mine was 10 turns.

Keeping track of adjustment nut turns is important because once you get the system all back together, the adjustment nut controls the centering of the system.

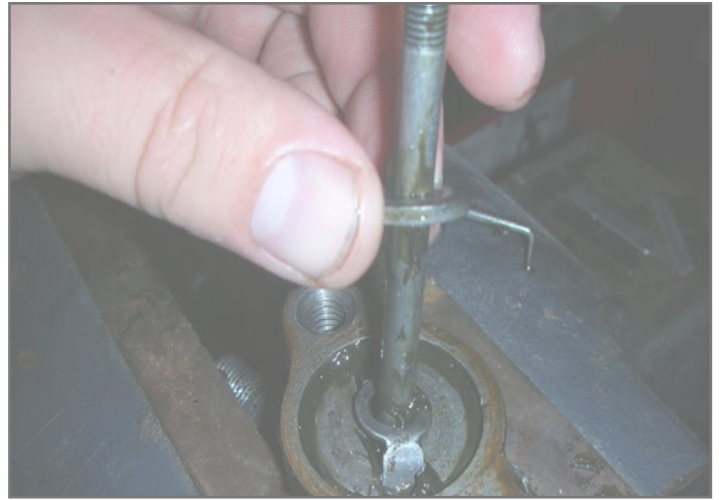
**Figure 4: Valve shaft (rod), shaft washer & sleeve key**

When you separate the ball stud housing from the valve housing you will see the sleeve key with a washer on top (figure 4). Unscrew the ball stud adjustment nut from the rod (Figure 5).

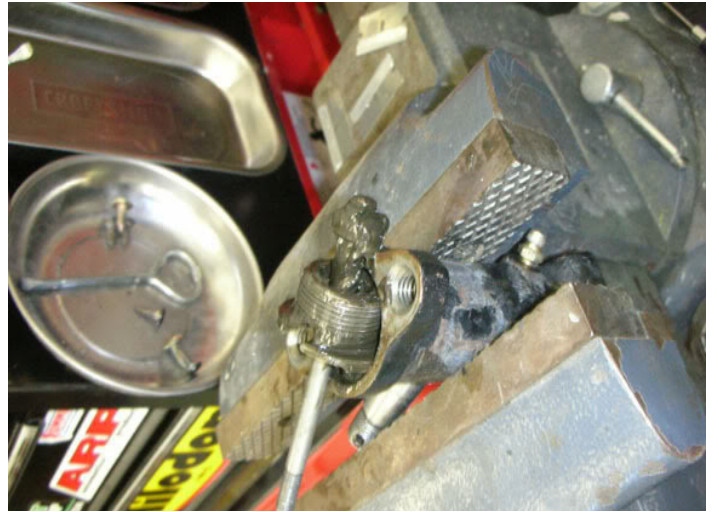
**Figure 5: Rod removed with ball and adjustment nut**

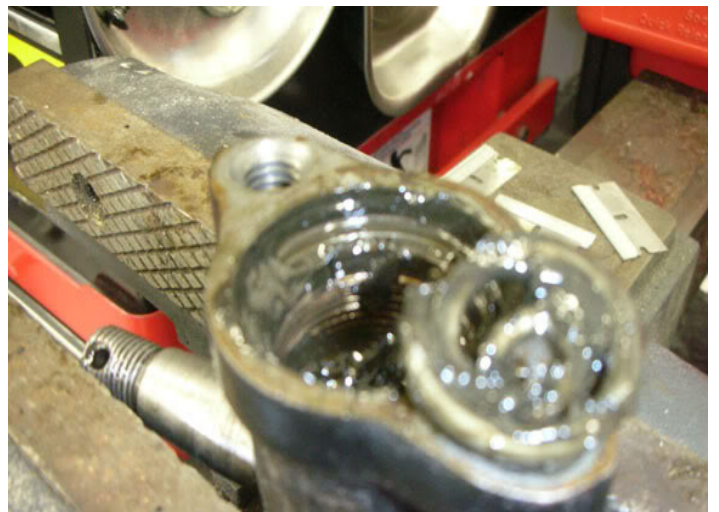
**Figure 6: Housing, o-ring groove & ball seat spring**

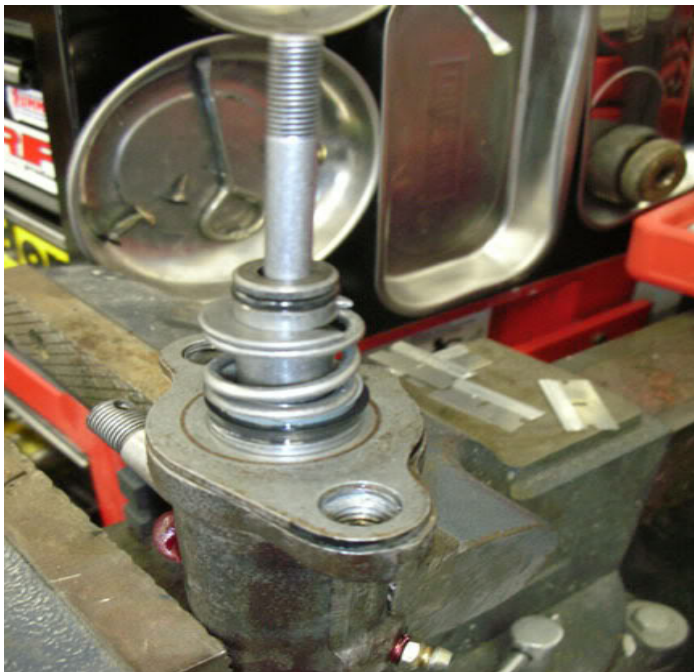
**Figure 6: Ball stud side up with part stack assembly**

Once you remove the sleeve key and the ball adjustment nut, there is a spring under it that you want the point end towards the ball seat cup (Figure 6). The two ball seats surround the the ball stud that exits the housing.

The way to do this is to stack the parts on the ball stud side of the unit and lower the hydraulic side down on it. Well in theory that may work but I found a better way. This is how it should look if you try to stack them (Figure 6)

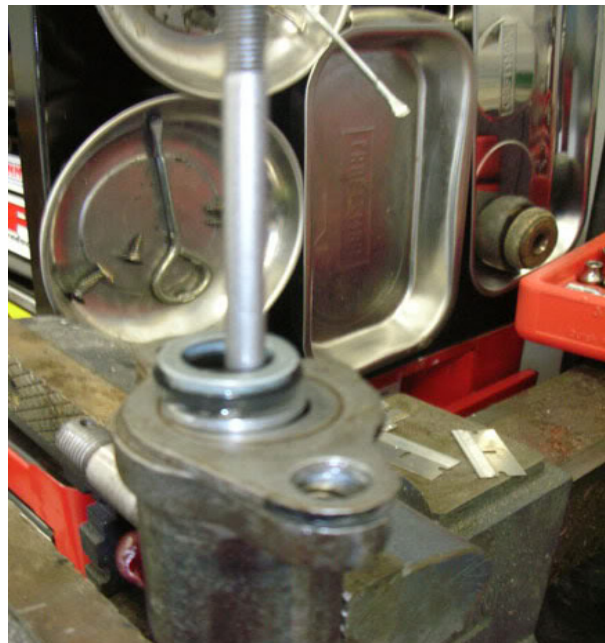
**Figure 7: Spring retainer (top) and annulus seal**

Now to get to the point I think the Chassis Overhaul Manual is a little lacking. The order to rebuild the hydraulic side starts with Figure 7. It shows the spring retainer and seal (underneath) and washer. Remember the seal lip goes up - towards the hydraulic side.

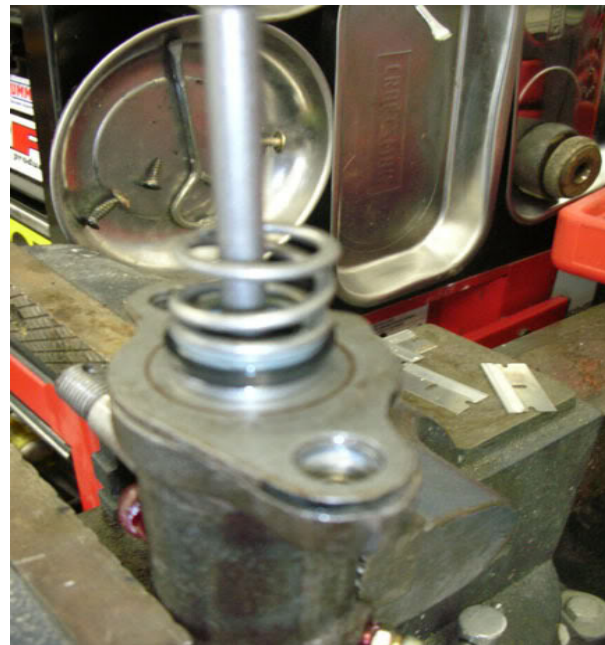
**Figure 8: Add spring to stack**

Add the spring (Figure 8); Then the valve reaction spool (Figure 9). Next install the keeper or lock ring in the slot of the valve reaction spool (Figure 10).

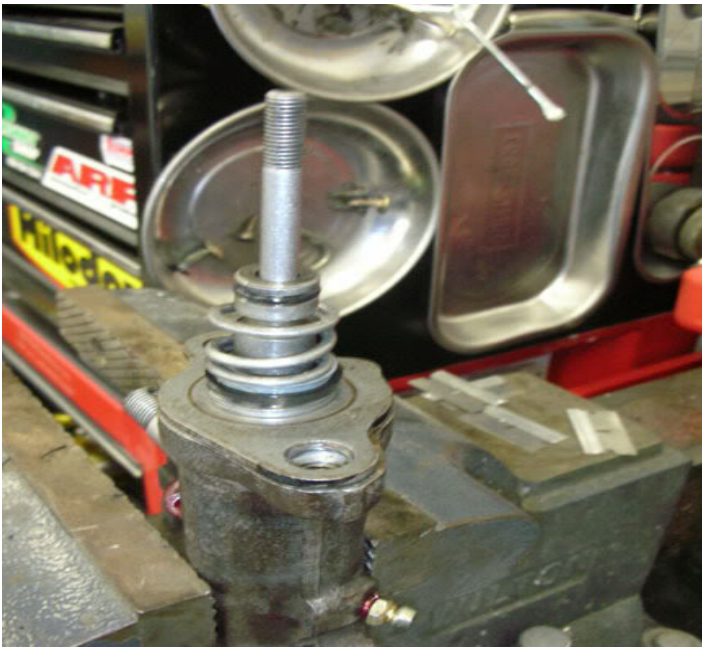
**Figure 9: Valve reaction spool (piston) slides over valve shaft and inside the valve spring**

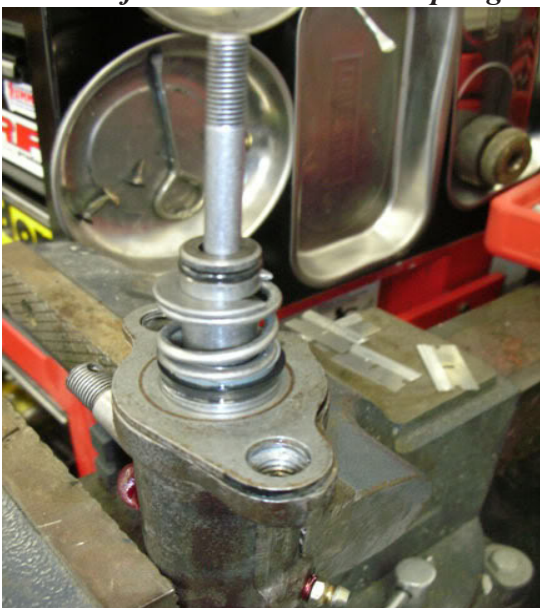
**Figure 10: Spring thrust washer (keeper) inserts into valve spool and secures valve spring assembly**

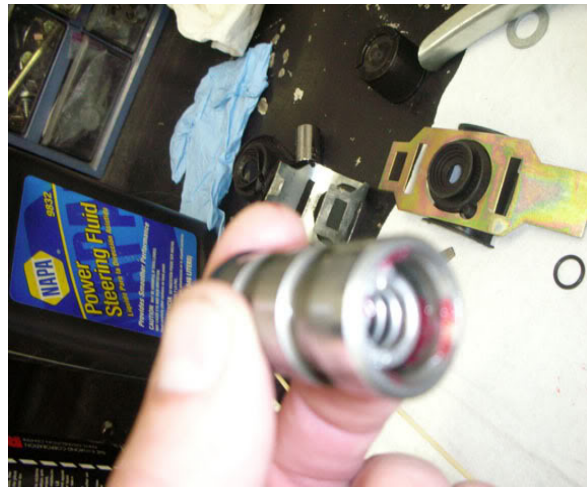
**Figure 11: Valve spool & valve adjustment spring**

valve reaction spool and an adjustment spring that floats inside the valve spool (Figure 11). Use a little bit of grease to hold the spring inside. This assembly loads into the valve housing (top half).

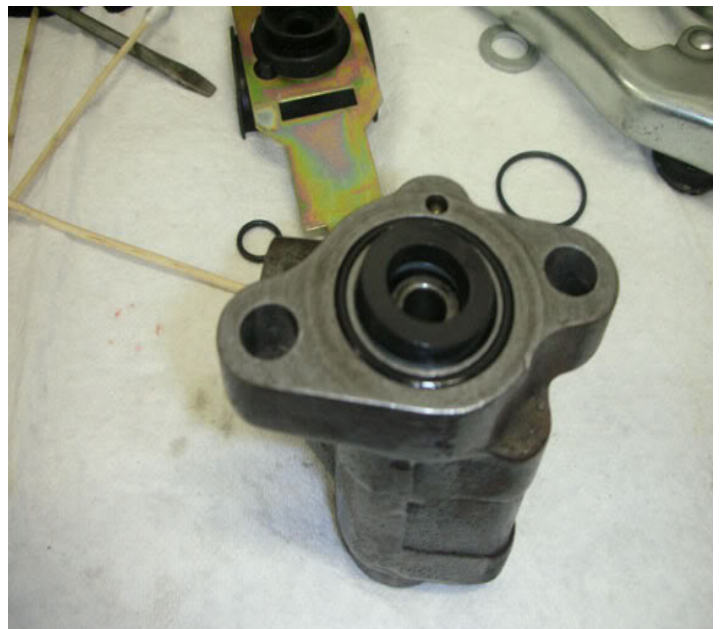
**Figure 12: Valve housing with seal and o-ring**

With the ball stud stacked in the vise and the spool valve inserted in the valve housing (hydraulic end) you could lower it onto the ball stud housing. Unfortunately I could not get the seal to pass into the valve housing. So, I turned the valve housing over and loaded the stack into it. You will have to apply some pressure to the seal to compress the spring in the spool. All the while working to ensure the seal remains in the bore.

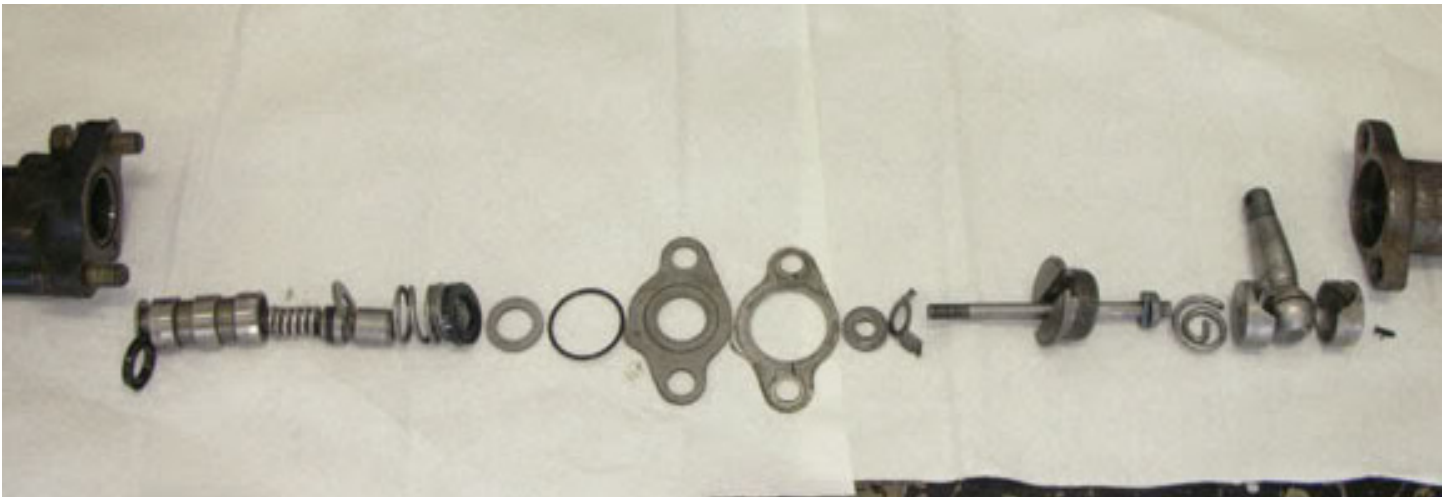
**Figure 13: Complete PSCV parts layout from valve housing (hydraulic end) to ball stud housing**

thumbs out and you have now just joined the two sides. For reference, Figure 13 illustrates the parts in the order of their assembly similar to the layout found in the Chassis Overhaul Manual and Shop Manuals.

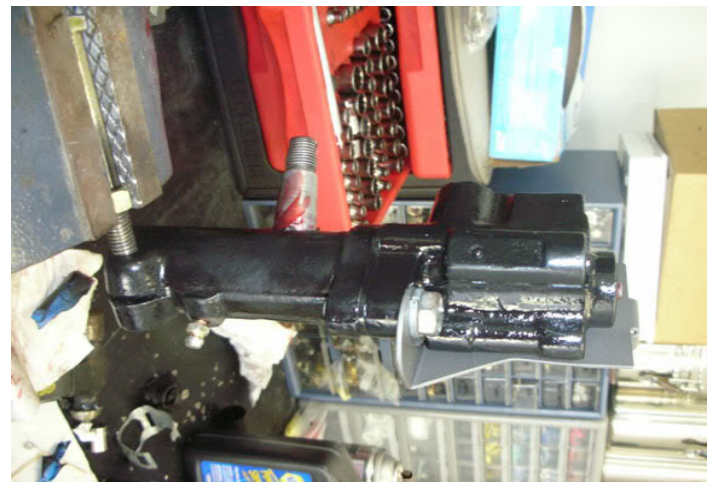
**Figure 14: Completed rebuilt PSCV assembly**

If you wish to complete your PSCV rebuild project with finishes that approximate those of the Saginaw plant, read on. The entire unit was painted as a single assembly and included the housing halves, bolts and nuts that secured the two halves and the rubber dust boot and clamp that wrapped the ball stud. The assembly was painted semi-gloss black while the ball stud was a black phosphate plated finish.
