## Tired of Key Twisting

TIME TO POWER UP THOSE 30-YEAR-OLD DOOR LOCKS

BY TOM RUSSO

**If your 1978-82 Corvette is a daily driver equipped with RPO AU3 power door locks that haven't worked like you believe they should...we've got tips that will restore them to their original functionality.**

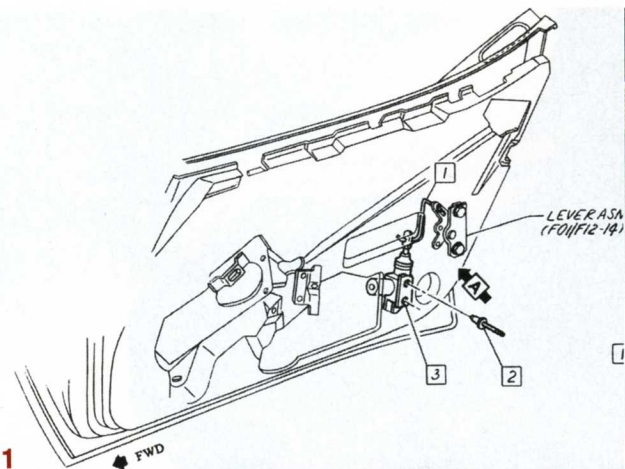
**1** Power Door Lock Actuator & Linkage. Taken from the AIM and shows the interior side of a door panel and location of the actuator.

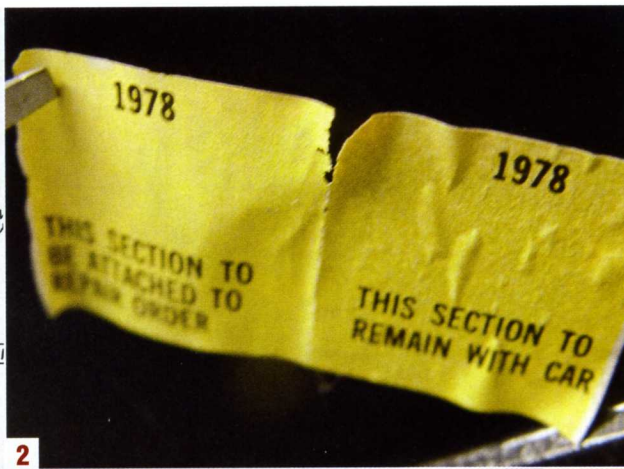
**2** Door panel tag: When an inspector identified repairs, the tag was removed by the repairman and attached to the repair order inspection sheet.

According to John Hinckley, Chevrolet used the tags on all vehicles and required dealer service departments to attach it to warranty work claims when the claim was for window adjustment. The tag proved that the technician was inside the door panel, and Chevrolet didn’t pay claims unless the tag was on the warranty work claim.

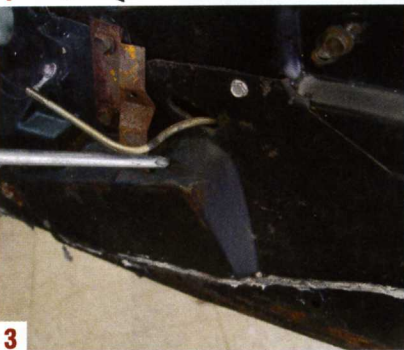
**3** Interior side of door with interior panel removed.

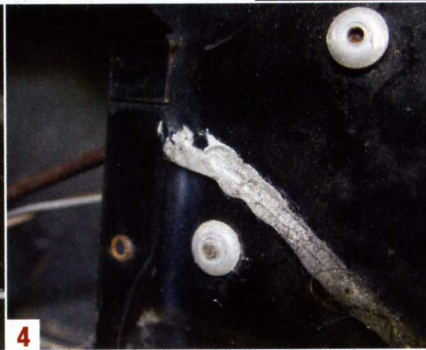
**4** Two rivets secure actuator in place. Drill or grind to remove.

The actuator has a plunger on one end that is covered by a plastic boot. Over the years, the plastic deteriorates and exposes the plunger to moisture, which eventually will corrode and lock up. The actuators are riveted in place. Drill out the rivet or grind off its head, but be careful

not to grind into the support bracket. Once removed, you can use a 1/4-20 nut and bolt to install its replacement. Before re-installing the actuator, proceed with linkage maintenance, as its absence will provide more space to work inside the door panel compartment.

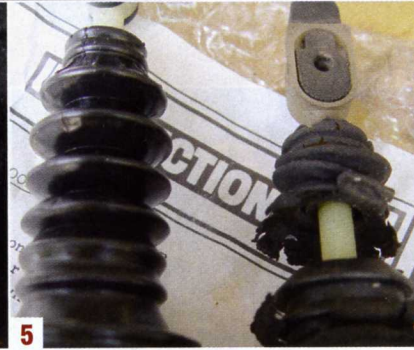
**5** Service replacement actuator & original actuator. Note the brittle, broken plastic boot on the original actuator.

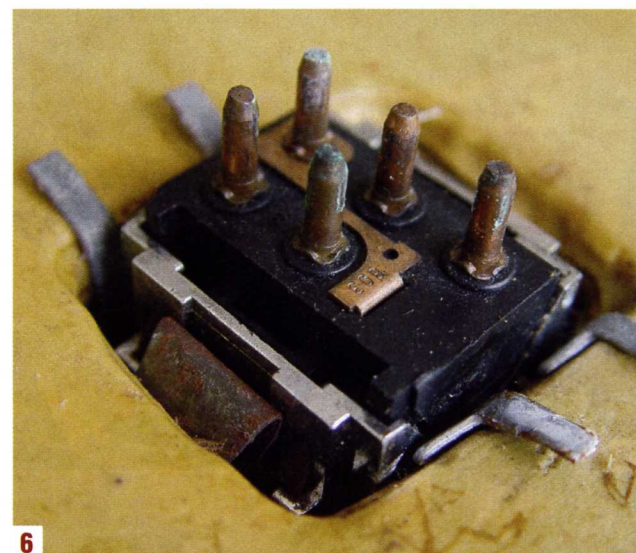
6

each contact with an ohmmeter to confirm continuity. When you activate the door lock switch, you should see a voltage spike at each connection, except ground. We discovered with our pace car that one contact was bad and failed to unlock the door. Wire colors on each switch will differ because each side operates the other. The power lead comes in orange (both sides), and the passenger side provides ground (black). Therefore, both sides must be connected to operate the door locks.

**6** Door switch terminals show thirty years of corrosion.

Reconnect the door switch cable harness to the door panel connector, but first check the door switch terminals. If they look corroded or dirty, use emery paper and clean them up. With the panel connected to the cable, test

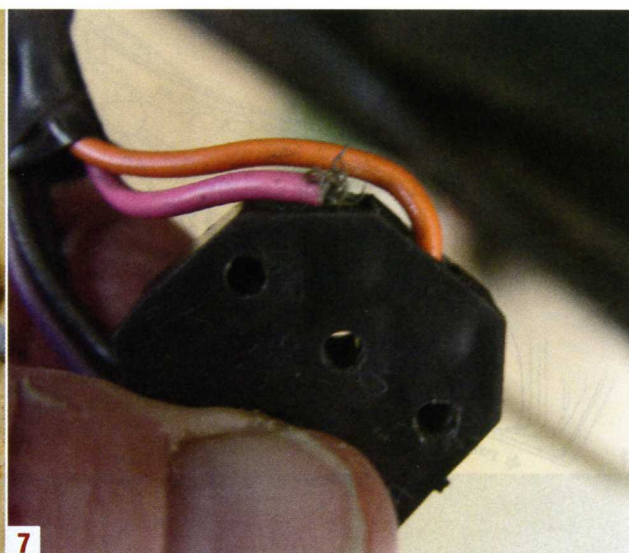
7

**7** Door switch connector and frayed wire.

Inspect the wires that feed into the connector. We discovered that one of the leads was frayed. We replaced the connector, as well as the door switches on both sides of our pace car. When replacing wires, solder the wires and use shrink-wrap tubing to secure the connection. Take all measures to eliminate moisture penetration of the electrical connections and wiring.

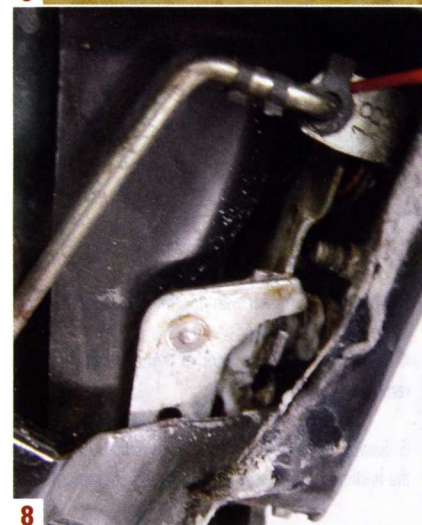
8

**8** Lock linkage that activates plunger and doorknob. Note the spring clip that secures rod to lever.

**LINKAGE MAINTENANCE:** Unless you plan a major overhaul to window channels and linkage by removal of all hardware, the most efficient means to remove accumulated "gum" from the linkage is to use an aerosol cleaner like brake cleaner. The nozzle extension helps to target the fluid, and the force will be sufficient to clean up the linkage and improve its movement. Target your cleaning toward the linkage assemblies at the lock mechanism. Also inspect that spring clips (Figure 8) secure linkage rods to levers and the lock mechanism. Spring clips are both right hand and left hand, and they secure all rods to levers, except the actuator plunger rod.

Use a screwdriver tip or your finger to activate the door lock linkage. This will activate the linkage as it runs to the actuator and door lock knob. It will also activate the linkage as it runs up to the key. Binding occurs where the three sets of linkage connect at the lock mechanism. Also, clean up the latch mechanism that captures the striker bolt. Once cleaned to your satisfaction, use a lubricant that restores the lubricating qualities to your linkage.

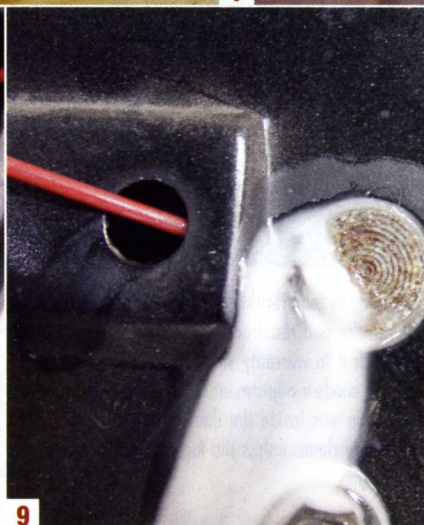
9

**9** Linkage lever assembly: Shows lubricant discharge from a large rivet.

An additional part to clean and lubricate is the linkage lever assembly. This assembly is equipped on both power and non-power lock cars. The oval slot on the lever is used for the actuator linkage when AU3 is specified and serves as a fulcrum for the actuator linkage. When the door switch is activated, the plunger pushes or pulls the linkage, and the fulcrum activates the linkage up through the door handle. While cleaning and lubricating the linkage, don't forget the lever assembly. You may find that once the actuator is removed, this plunger linkage falls off the fulcrum. Locate the slot on the fulcrum and insert the linkage into the slot. You'll learn why you don't want the actuator installed yet!

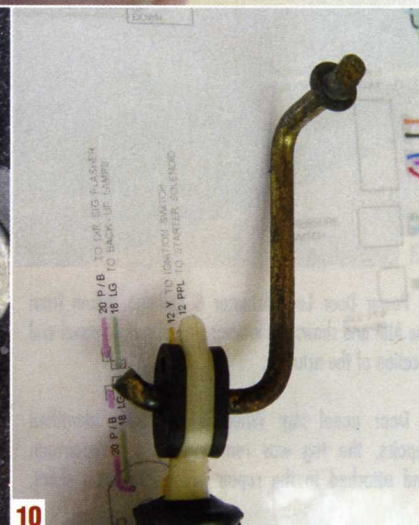
10

**10** Plunger linkage rod.

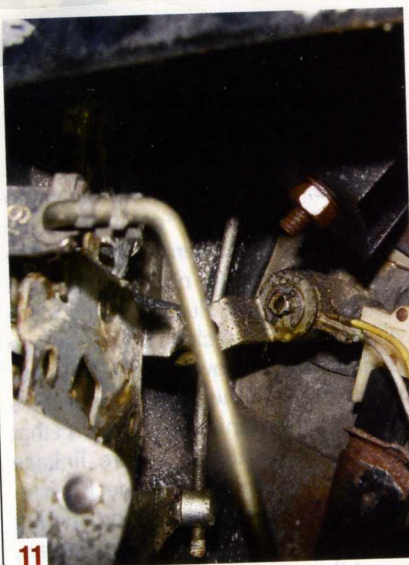
**11** Removal of plastic guard reveals anti-theft lock cylinder & lock mechanism. Note the yellow and light-blue wire from the lock. Also note the film residue (yellowish) after cleaning.

must be down, and you must loosen the plastic guard. Two screws hold it in place. Remove the screws and work the guard down into the window channel. It won't fall down, but will allow enough room that you can view with a flashlight and small mirror the lock cylinder, its linkage and the exterior door-adjusting rod.
