## ■ TECHNICAL SHARK FUEL GAUGE FIX

# Restore Your C3 Fuel Tank Sending Unit

BY TOM RUSSO

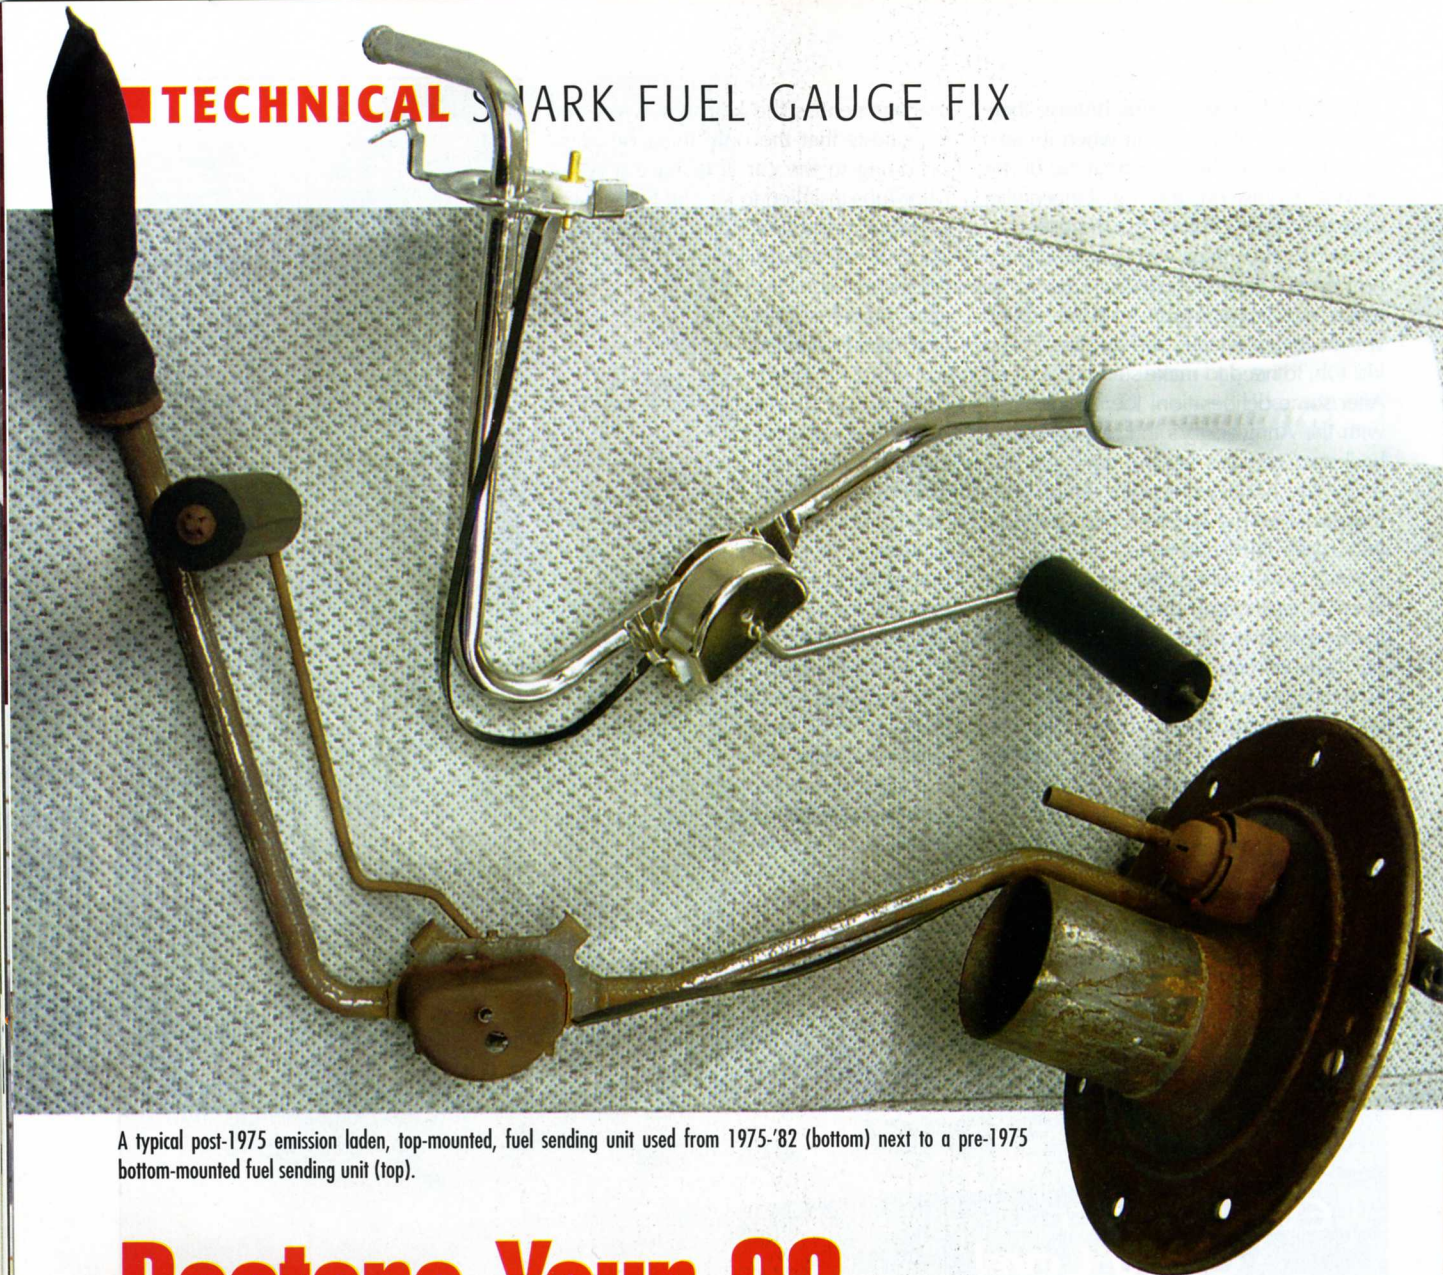
A typical post-1975 emission laden, top-mounted, fuel sending unit used from 1975-'82 (bottom) next to a pre-1975 bottom-mounted fuel sending unit (top).

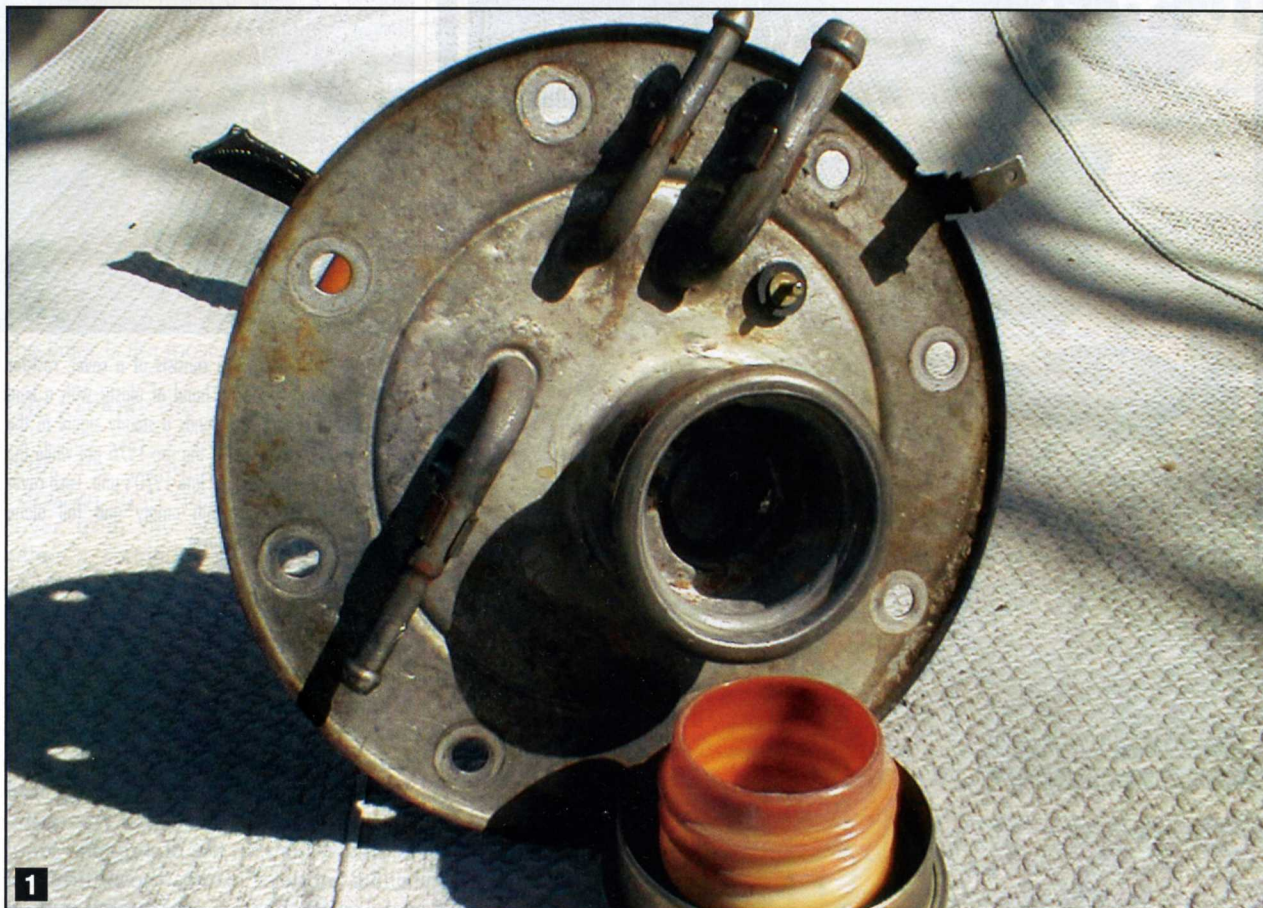
**1** The tank attachment plate and filler neck for a top-mounted 1975-'82 assembly. It shows the fuel return tube, fuel delivery tube and the ECS tube from the liquid/vapor separator valve to the charcoal canister. Also, note the fuel gauge electrical connection above the filler neck.

Late model C3 AIMS refer to this collection of assemblies (Figure 1) as the "Fuel Meter Plate Assembly." If you search for a replacement part you'll find it listed as "fuel tank sending unit." However, as we describe how it works and the various components, you'll understand why GM referred to it as an assembly. The reference unit shown here is for a 1978, which is consistent
